SIM 34 01 24

2024-10-10

RECALL 24V-104: INTEGRATED BRAKING SYSTEM (IB)

This Service Information Bulletin (Revision 5) replaces SI M34 01 24 **dated September 2024**.

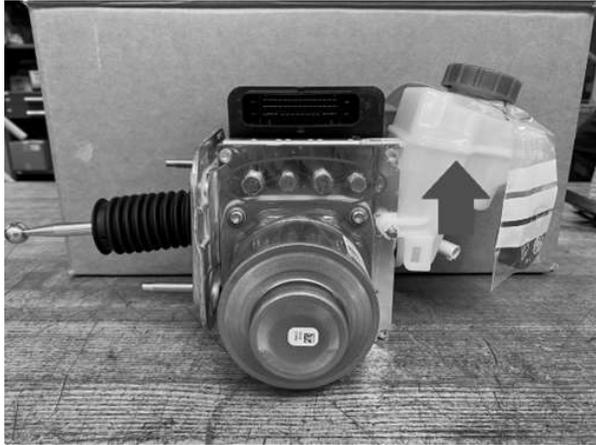
“Wet” IB pre-filled: Brake fluid reservoir is filled (arrow) and brake fluid line ports are plugged with bolts (circled)

Part numbers:
 5B5F8F1
 New, additional part number (also refer to Parts Information):
 5B67B85

If you have received a “wet” unit, follow the repair per the Attachment 1, “Service Function and replace Wet IB pre-filled”.

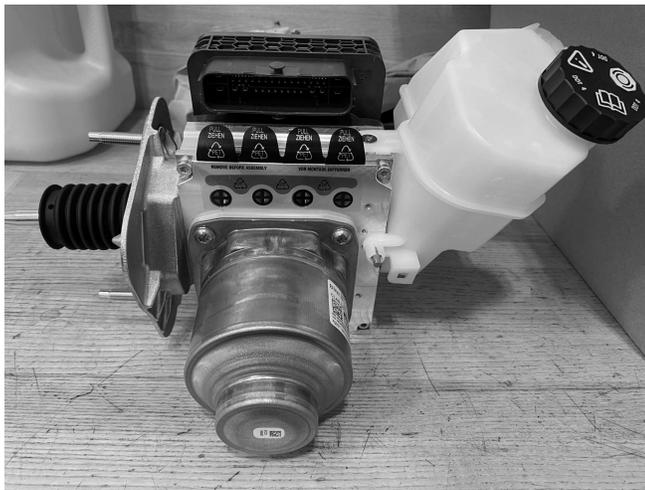
“Dry” IB unfilled: Brake fluid reservoir is empty; brake fluid line ports are sealed with labels.

Part numbers:
 5B3C874

Note: Additional work is necessary to install these “Dry” units, refer to the Claim Information section.

If you have received a “dry” unit, follow the repair per the Attachment 2, “Service Function and replace Dry IB unfilled”.

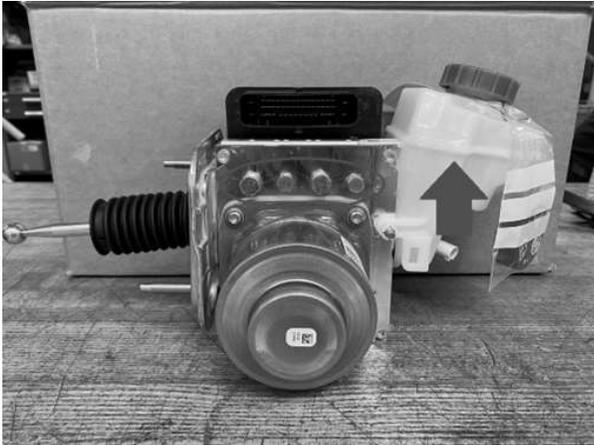
“Wet” IB pre-filled: Brake fluid reservoir is filled (arrow) and brake fluid line ports are plugged with bolts (circled)

Part numbers:
5B5F8F1 Must have Blue-Dot

New part number
5B67B85 Will not have Blue-Dot

See step 1 and 2 for inspection process

No further inspection required

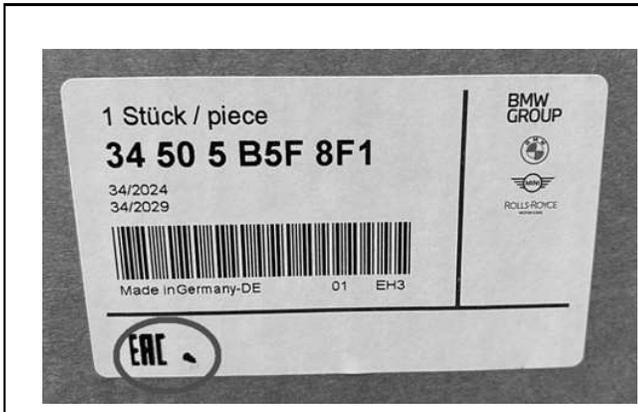
1. For a “Wet” pre-filled part number listed above in blue. Verify the blue dot is located on the part number label as shown in the photo.

Note: Photo shown for location of blue dot on the parts label and does not indicate the part number for all models

3. Return the part if the Blue-Dot is not found on the label or unit.

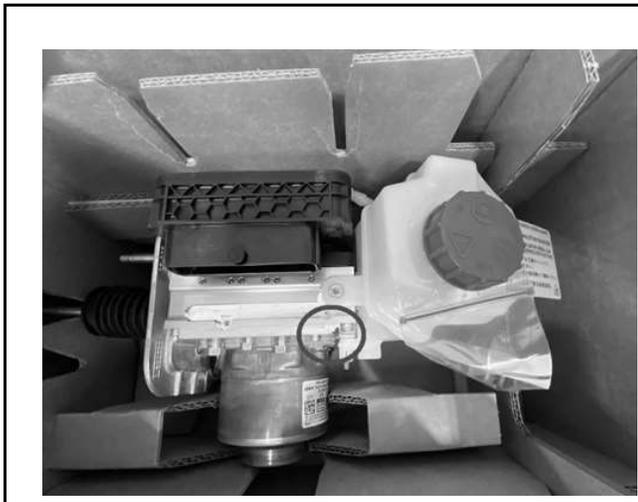
2. Verify the blue mark is located on the new component as shown in the photo.

Note: Some IB’s may have an additional blue dot on the brake fluid reservoir. Disregard that blue dot. The only blue mark to be verified is shown here.

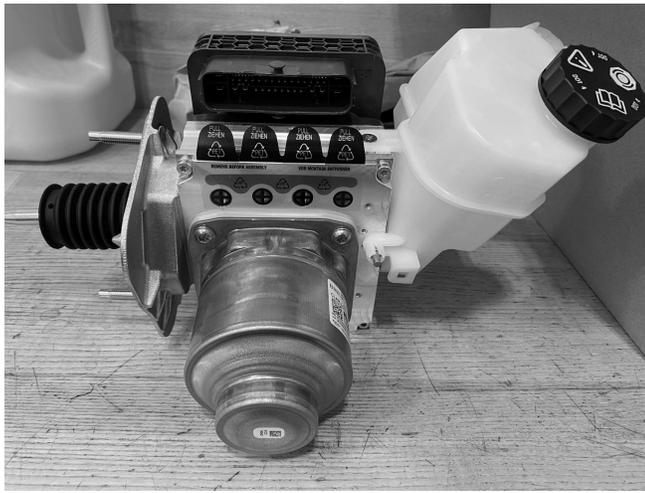
“Dry” IB unfilled: Brake fluid reservoir is empty; brake fluid line ports are sealed with labels.

Part numbers:
5B3C874 Blue-Dot inspection not needed

Note: Additional work is necessary to install these “Dry” units, refer to the Claim Information section.
