This Service Information bulletin supersedes SI M11 02 07 dated **September 2010**.

### Rattle Noise from Engine

R55 Cooper S with N14 engine

R56 Cooper S with N14 engine

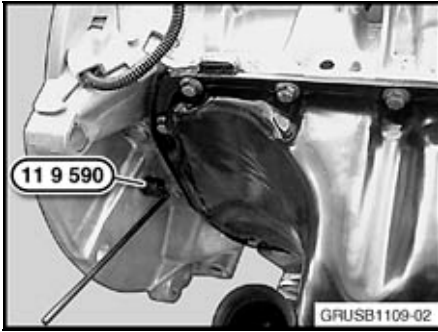
6. Remove the right-hand wheel arch trim to access the crankshaft central bolt.
7. Disconnect the battery, remove ignition coils and spark plugs. Turn the engine by hand to move the

flywheel to approximately 90° before TDC.

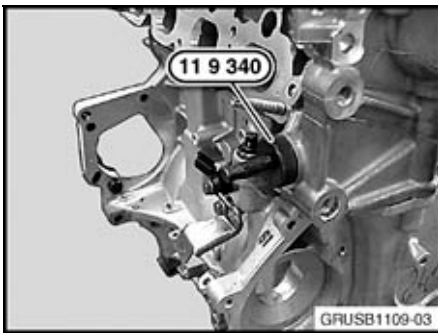
8. Install the locating pin (Special Tool 11 9 590) to lock the position of the engine.

9. Remove the chain tensioner and collect the residual oil with a shop towel.

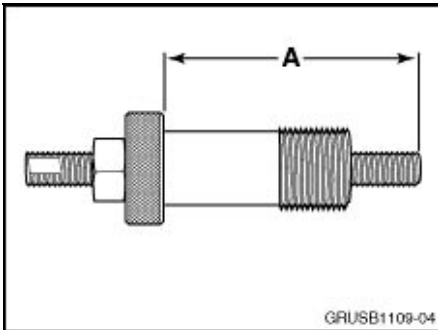
10. Fit the chain tensioner (Special Tool 11 9 340) without the seal ring and with the lock nut loose. Pretension the chain tensioner with Special Tool 00 9 250 to **0.6 Nm**. Finger-tighten the lock nut on Special Tool 11 9 340.

11. Remove the chain tensioner (Special Tool 11 9 340) from the engine, with the lock nut still tight. Measure the distance (A), as described in the illustration.

12. If distance (A) is less than 68mm (and the noise can be reproduced only between 1,600-1,800 rpm), then only replace the chain tensioner with P/N 11 31 7 607 551 (refer to parts list A), as per Repair Instruction REP 11 31 090 (Installing and removing/replacing chain tensioner piston N14).
13. If distance (A) is 68mm or greater (and the noise is reproducible both at 1,600-1,800 rpm range as well as at idle speed when cold), replace the following components in the list below (refer to parts list B). If you are uncertain regarding repair attempts already made, each chain tensioner part number is stamped on the outer sleeve. It must be removed from the engine in order to read the part number.
