SI M 11 02 07  
Engine

March 2009  
Technical Service

**Rattle Noise from Engine**

R56 Cooper S with N14 engine

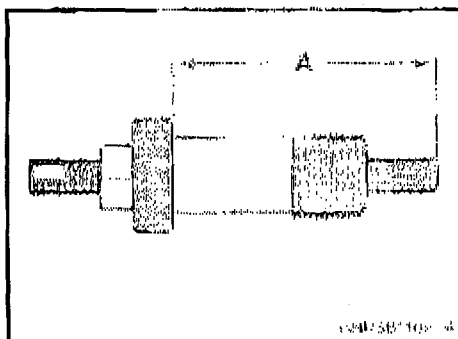
11. Remove the chain tensioner (Special Tool 11 9 340) from the engine, with the lock nut still tight. Measure the distance (A) as described in the illustration.

12. If the distance (A) is less than 68 mm, then only replace the chain tensioner with P/N 11 31 7 598 956, as per Repair Instruction RA 11 31 090 (installing and removing/replacing chain tensioner piston N14).

13. If the distance (A) is 68mm or greater, then replace the following components:

10. Fit the chain tensioner (Special Tool 11 9 340) without the seal ring and with the lock nut loose. Pretension the chain tensioner with Special Tool 00 9 250 to 0.6 Nm. Finger-tighten the lock nut on Special Tool 11 9 340.

- Chain tensioner
- Timing chain
- Guide rail
- Tensioner rail
- Sliding rail
- Sprocket on the crankshaft
- Bearing bolts for the tensioner and guide rails

Refer to Repair Instruction RA 11 31 051 (Replacing timing chain N14).
