## FOUL, MUSTY ODOR FROM HVAC: WET FOOTWELL CARPET

This Service Information bulletin replaces SI M64 01 11 dated May 2017.

F54 (Cooper, Cooper S Clubman)	F55 (Cooper, Cooper S Hardtop 4 door)	F56 (Cooper, Cooper S Hardtop 2 door)	F57 (Cooper, Cooper S Convertible)
F60 (COOPER, COOPER S, COOPER WORKS)

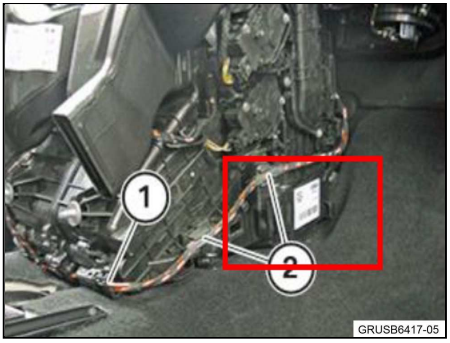
<p style="text-align: right; font-size: small;">GRUSB6417-05</p>

To select the correct micro filter you need to get the production date and manufacture from the printed label on A/C housing as shown.  Reading the production date as: D.M.Y We have 2 manufactures UK or CZ The new micro filter is shorter and does not need a spacer.

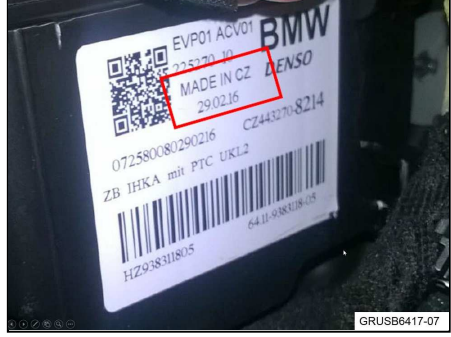
<p style="text-align: right; font-size: small;">GRUSB6417-07</p>
<p>Evaporator Housing manufactured in CZ produced to January 24, 2016 (24.01.16) or Evaporator Housing manufactured in UK produced to February 01, 2016 (01.02.16) The lower micro filter is already fitted with spacers and prevents absorption of condensation. Use one of the below part numbers: <u>64 11 6823724</u> "Micro filter" <u>64 11 6823725</u> Option code SA 534 "MICROFILTER/ACTIVATED CARBON CONTAINER"</p>	
<p>Evaporator Housing manufactured in CZ produced from January 25, 2016 (24.01.16) or Evaporator Housing manufactured in UK produced from February 02, 2016 (02.02.16) The micro filter is shorter and does not need spacer. Use one of the below part numbers: <u>64 11 6835404</u> "Micro filter" <u>64 11 6835405</u> Option code SA 534 "MICROFILTER/ACTIVATED CARBON CONTAINER"</p>

Part Number	Description	Quantity
<b>Evaporator Housing manufactured in "CZ" before 24/01/2016</b>		
With option code SA 530		
<u>64 11 6 823 724</u>	Micro-filter	1
With option code SA 534		
<u>64 11 6 823 725</u>	Micro-filter/Activated Carbon Container	1
<b>Evaporator Housing manufactured in "CZ" on 24/01/2016 or after</b>		
With option code SA 530		
<u>64 31 6 835 404</u>	Micro-filter	1

With option code SA 534		
64 31 6 835 405	Micro-filter/Activated Carbon Container	1
<b>Evaporator Housing manufactured in "UK" before 01/02/2016</b>		
With option code SA 530		
64 11 6 823 724	Micro-filter	1
With option code SA 534		
64 11 6 823 725	Micro-filter/Activated Carbon Container	1
<b>Evaporator Housing manufactured in "UK" on 01/02/2016 or after</b>		
With option code SA 530		
64 11 6 835 404	Micro-filter	1
With option code SA 534		
64 11 6 835 405	Micro-filter/Activated Carbon Container	1
<b>Part Number</b>	<b>Description</b>	<b>Quantity</b>
64 11 9 262 789	A/C condensate drain	1
83 19 2 180 507	A/C cleaner 1000ml (liquid to clean evaporator using the MINI lance/wand)	As needed
83 19 2 360 464	Odor remover 100 ml (spray for vents)	As needed
