SI M 61 01 06
General Electrical Systems

Washer Fluid Leaks from Rear Washer Jet

R50 (Cooper) produced from 11/2003

R53 (Cooper S) produced from 11/2003

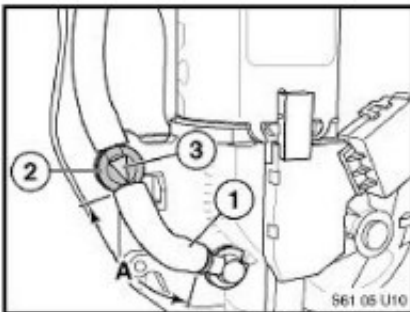
1. Cut the washer fluid supply hose (1) approximately 25mm from the end. (dimension A)
2. Install check valve (2) with the arrow (3) pointing toward the rear hatch wiper motor.

In case of a customer complaint, install a non-return valve to the rear wiper motor.
