MINI Cooper S R56 Timing Chain Rattle Noise from Engine

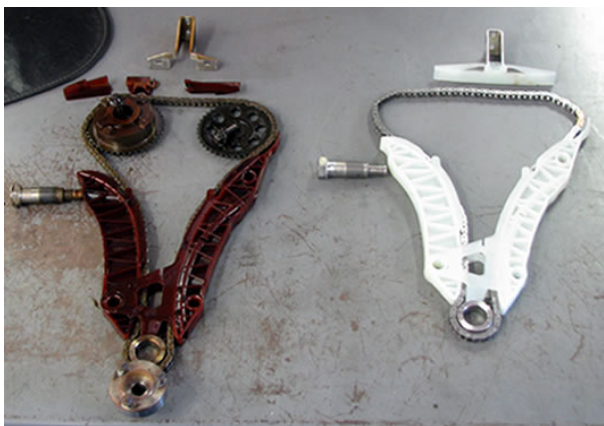
Diagram is provided to the left for quick reference of the timing chain components and their orientation or location on the engine.

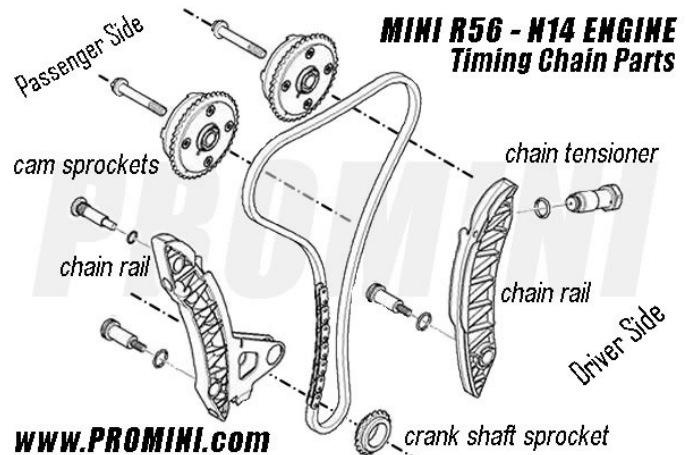
Common MINI Cooper S R56 Engine Failure:

This failure is the result of a weak or collapsed timing chain tensioner. If driven for an extended period of time the results will be a broken plastic tensioner rail or upper guide rail.

The noise you are hearing is the loose timing chain resulting from a collapsed timing chain tensioner. The slapping action of the timing chain will eventually break the tension rails. This condition will also effect cam timing and risk an eventual chain failure.

The chain will also need to be replaced at the time of repair in case of stretching or elongation. We do not recommend driving a vehicle in this condition other than at low R.P.M. to a nearby repair shop.

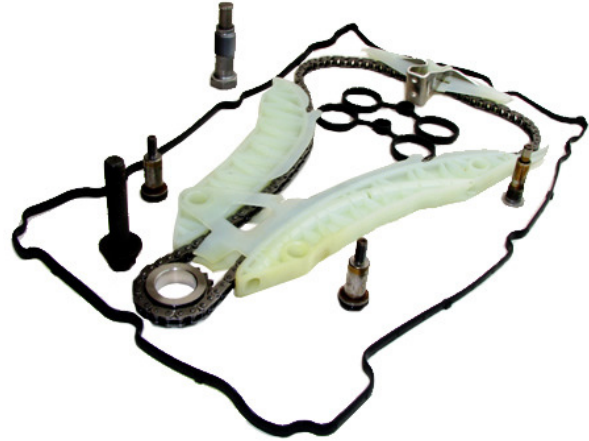
If ALL of the steps above are unsuccessful in eliminating the noise, start the Timing Chain Removal and Inspection process: To remove the timing chain you will need the [MINI Cooper S R56 Cam Timing Tool Kit for N12/N14 engines](#) Promini Part# 138007. (products shown fit model, please select your year for availability).

This tool is used to avoid improper cam timing on MINI Cooper engines, the factory has devised a cam timing system that locks the crankshaft and cams into a specific position prior to cylinder head removal.

This method was devised to avoid any misalignment, resulting in piston to valve damage. Unfortunately without these tools re-timing the camshafts after a valve job is almost impossible. The factory specification manual does not supply installation specifications. (includes all the necessary components to lock the crankshaft and flywheel position as well as the cams).

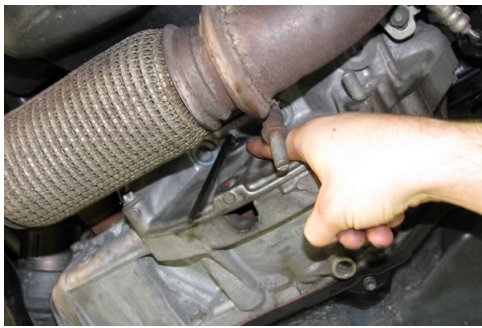
Step 1: Remove the right-hand wheel arch trim to access the crankshaft central bolt.

Turn the engine by hand to move the flywheel to approximately 90 degrees before TDC. (Top Dead Center) Install the locating pin (see photo) ([MINI Cooper S R56 Special Tool 11 9 590](#)) to lock the position of the engine.

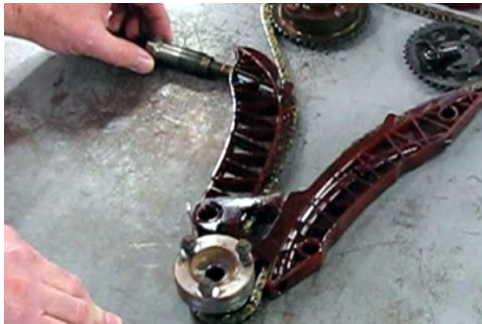
Step 2: Remove the chain tensioner and collect the residual oil with a shop towel.

(The tensioner is located on the side of the engine block timing cover facing the firewall.)

Fit the timing chain tensioner tool ([MINI Cooper S R56 Special Tool 11 9 340](#)) without the seal ring and with the lock nut loose. Pretension the chain tensioner tool to 0.6 Nm, and finger-tighten the lock nut.

Remove the chain tensioner tool ([MINI Cooper S R56 Special Tool 11 9 340](#)) from the engine, with the lock nut still tight. Measure the distance (A) as shown. If the distance (A) is less than 68mm, then only replace the chain tensioner piston with BMW P/N [11 31 7 598 956](#).

If the distance (A) is 68mm or greater, then replace the following timing chain components:
! Important: Do not replace the intake camshaft VANOS adjustment unit or the exhaust camshaft sprocket.

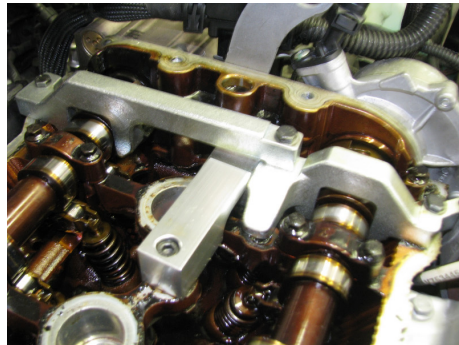
Step 6: Remove crankshaft bolt inside the crankshaft pulley which allows for timing chain cassette removal.

Step 7: Remove the old timing chain rail cassette by sliding the whole assembly up and out.

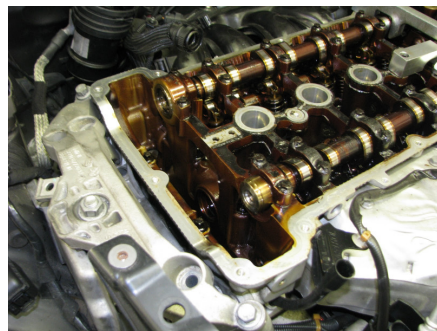
Step 8: Assemble the new timing chain rail cassette with the new crank sprocket held in place with the specially designed tabs.
