Removing and installing/replacing front left acceleration sensor (US version only)

REP-REP-RAR5265-6577532_US - V.5

65 77 532 Removing and installing/replacing front left acceleration sensor (US version only)

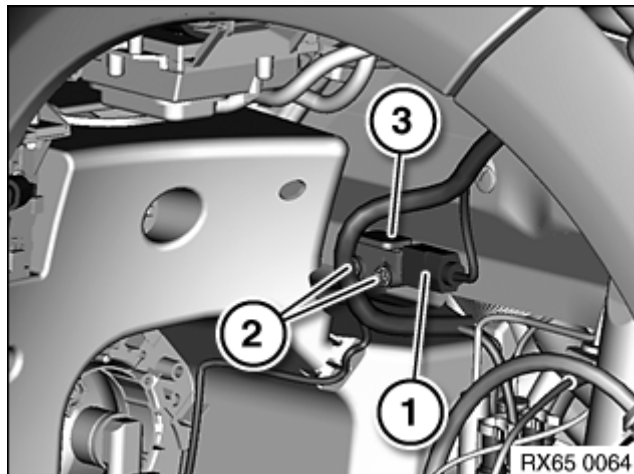
Disconnect plug connection (1).

Release screws (2) and remove acceleration sensor (3).

Replace screws (2). **6.6ftlb**

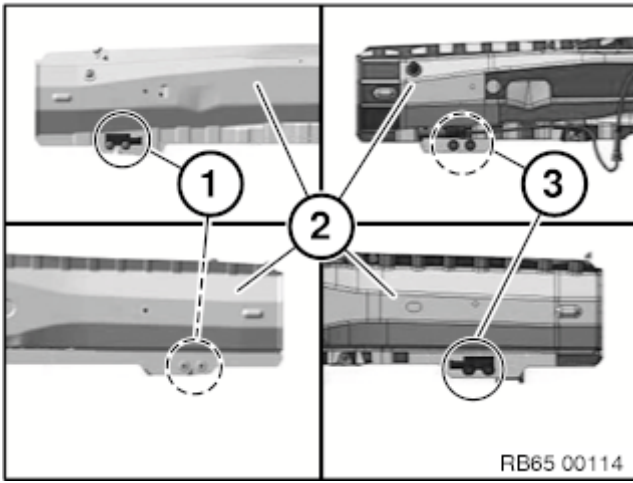
The installation position of the acceleration sensor has been changed on vehicles built after 08/2010:

(1) Installation position before 08/2010

(3) Installation position after 08/2010

The acceleration sensor (3) is positioned slightly offset on the other side of support (2).
