VIN: XXXXXXXX Vehicle: MINI/F56/HAT/Cooper/B38/AUTO/USA/LL/2014/11
System Version: 3.47.10.13054 Data Version: R3.47.10.13054

51 45 106 Removing and installing (replacing)
function carrier on instrument panel trim

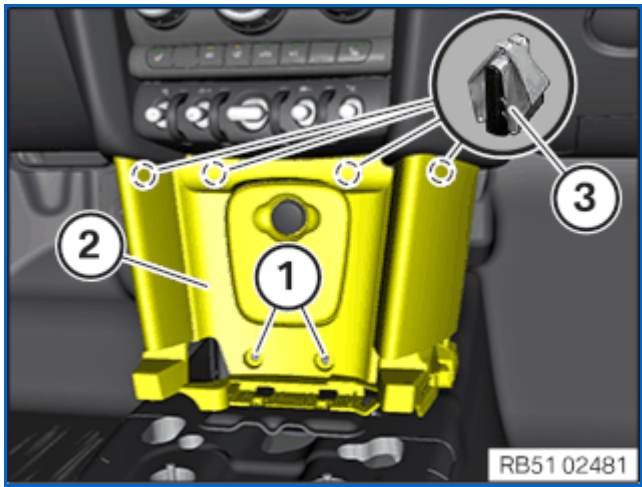
Removal:

- Release screws (1).
Release function carrier (2) from clamps (3).
Unlock associated plug connections and disconnect.
Remove function carrier (2).

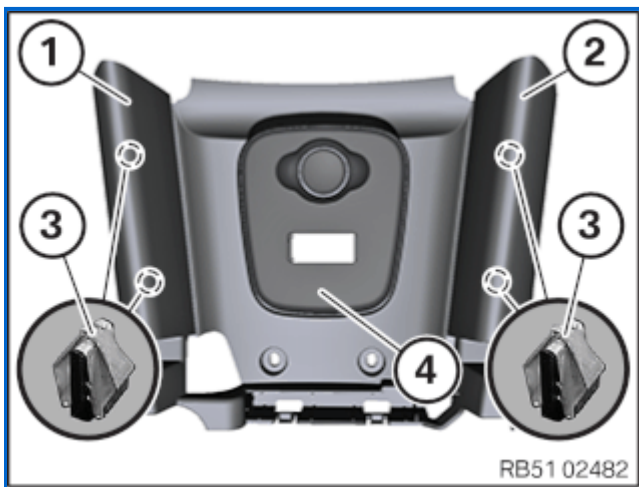
Replacement:

- Release cover (1, 2) from clamps (3) and remount.
Remount [cover for USB audio interface connecting socket \(4\)](#)

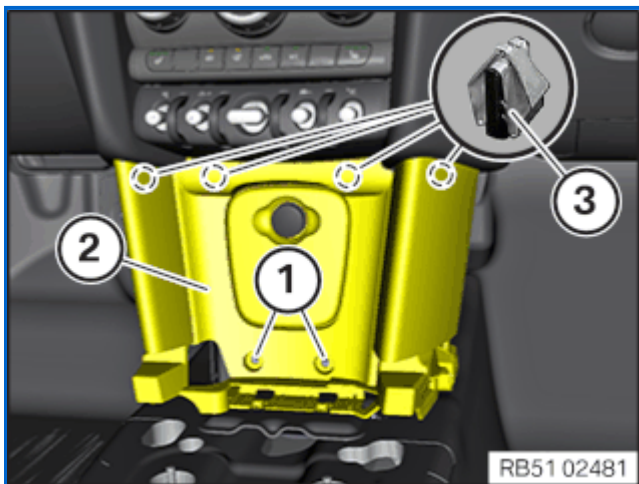
Installation:

Connect associated plug connections.
Engage function carrier (2) in clamps (3).
Tighten down screws (1).
