VIN:XXXXXXXXVehicle:MINI/F56/HAT/Cooper/B38/AUTO/USA/LL/2014/11

51 45 180

Removing and installing (replacing)
lower left instrument panel trim

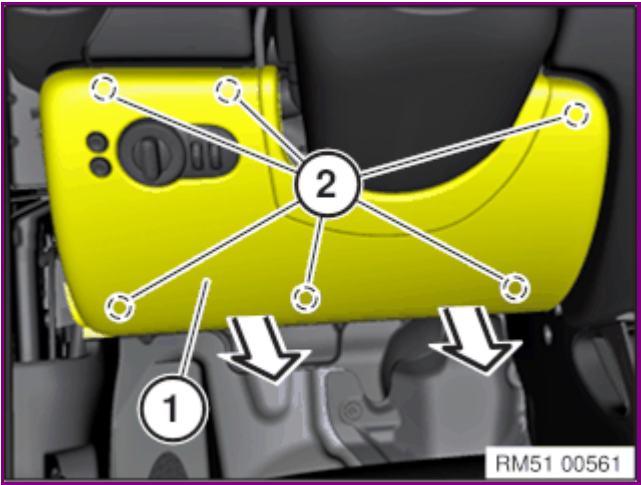
- Unclip the bottom instrument panel trim cover (1) from retaining clips (2) and remove.
- Unlock associated plug connections and disconnect.
- Remove bottom instrument panel trim (1).

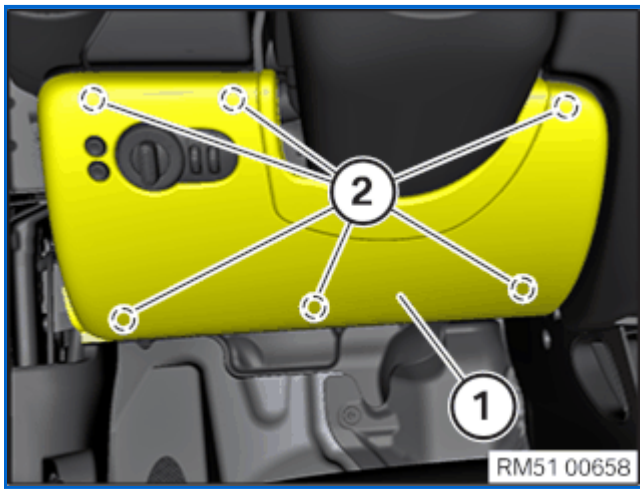
- Connect plug connections.
- Engage trim panel (1) in retaining clips (2).
