VIN:XXXXXXXXVehicle:MINI/F56/HAT/Cooper/B38/AUTO/USA/LL/2014/11

51 49 000

Removing and installing or replacing trim for rear lid

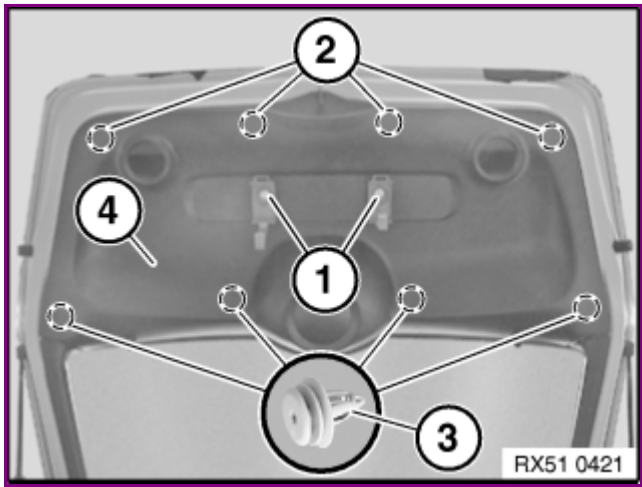
Remove warning triangle.

Release screws (1).

Remove warning triangle holder.

Release trim panel (4) from clips (2 and 3) and remove.

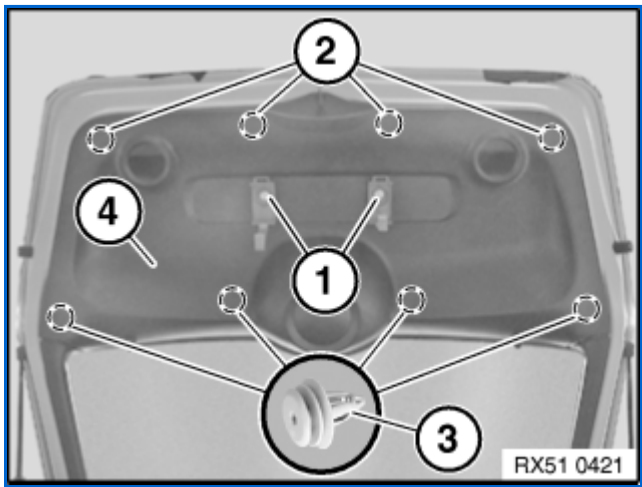
Replace faulty clips (2 and 3).

Position and clip in trim panel (4) with clips (2 and 3).

Secure warning triangle holder with screws (1).

Install warning triangle.
